CITY OF YORKTON <u>REGULAR COUNCIL MEETING AGENDA</u> Monday, June 28, 2021 - 5:00 p.m.

Building Condition Assessment Report

Former Ramada Inn

RE: YORKTON HOTEL STRUCTURAL CONDITION ASSESSMENT YORKTON, SK FILE NO. 119560

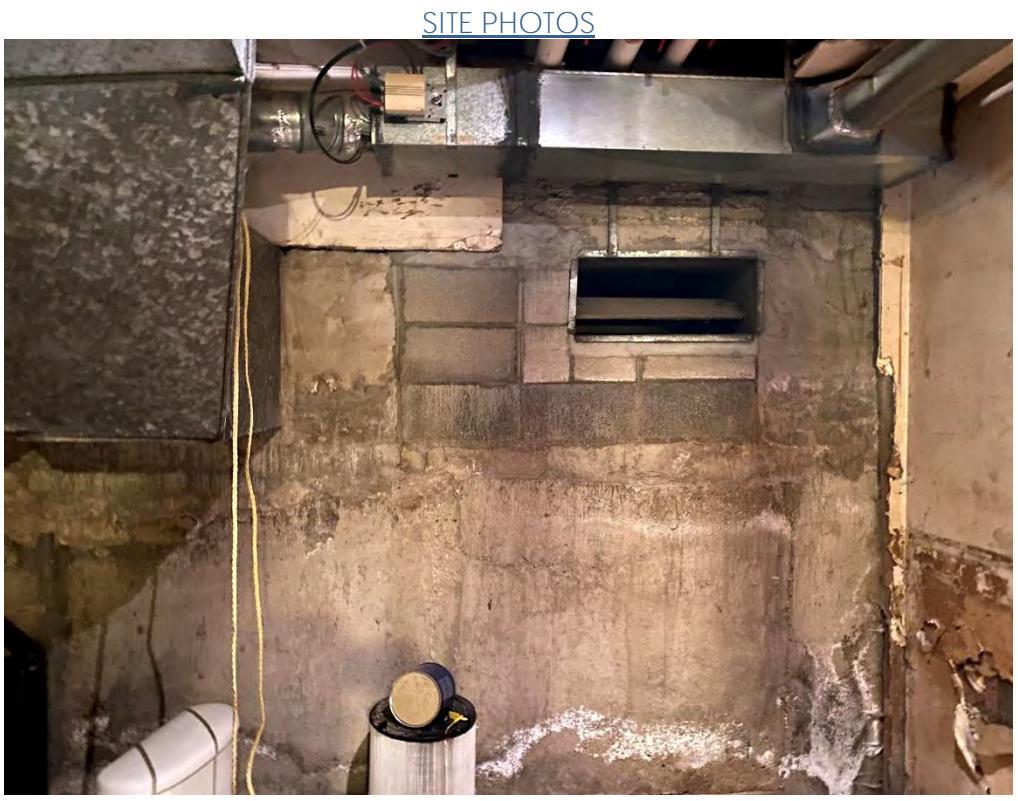
Photo 1- Foundation Wall Deterioration/Moisture Infiltration

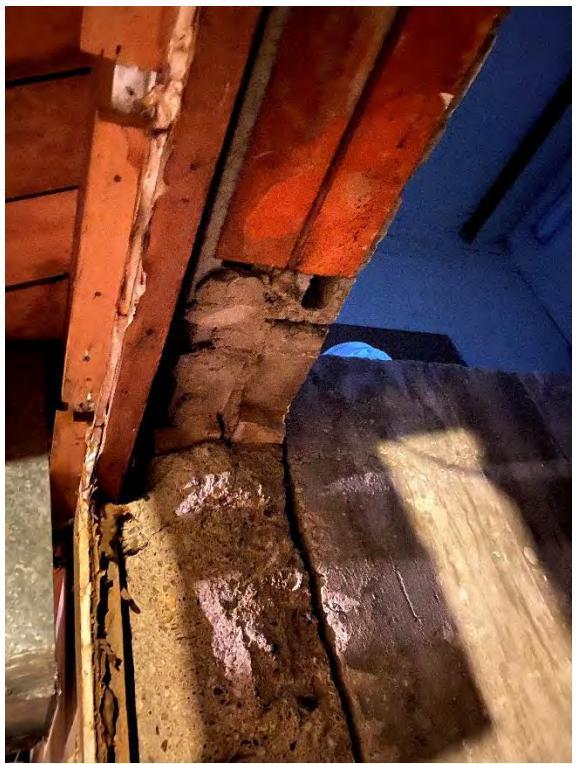
Photo 2- North Wall Lintel Not Properly Bearing on Foundation

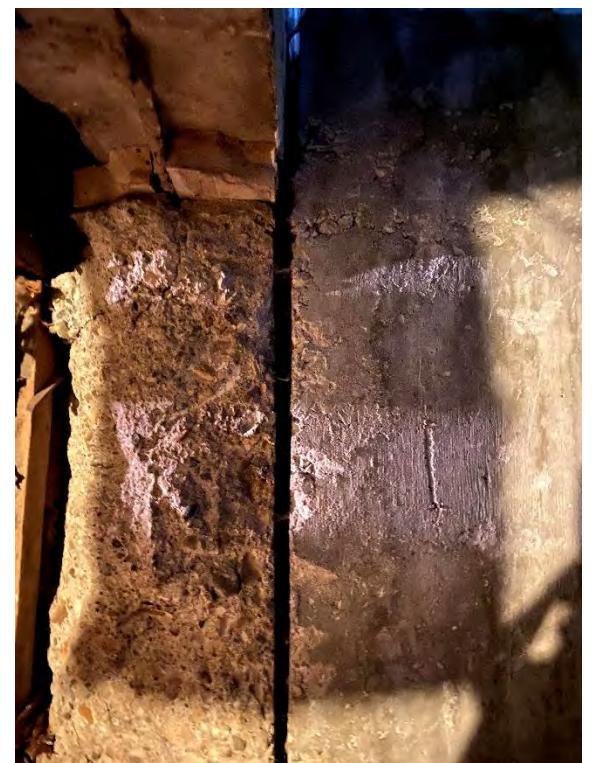
Photo 3- North Stair Foundation Differentially Moving from Basement Foundation

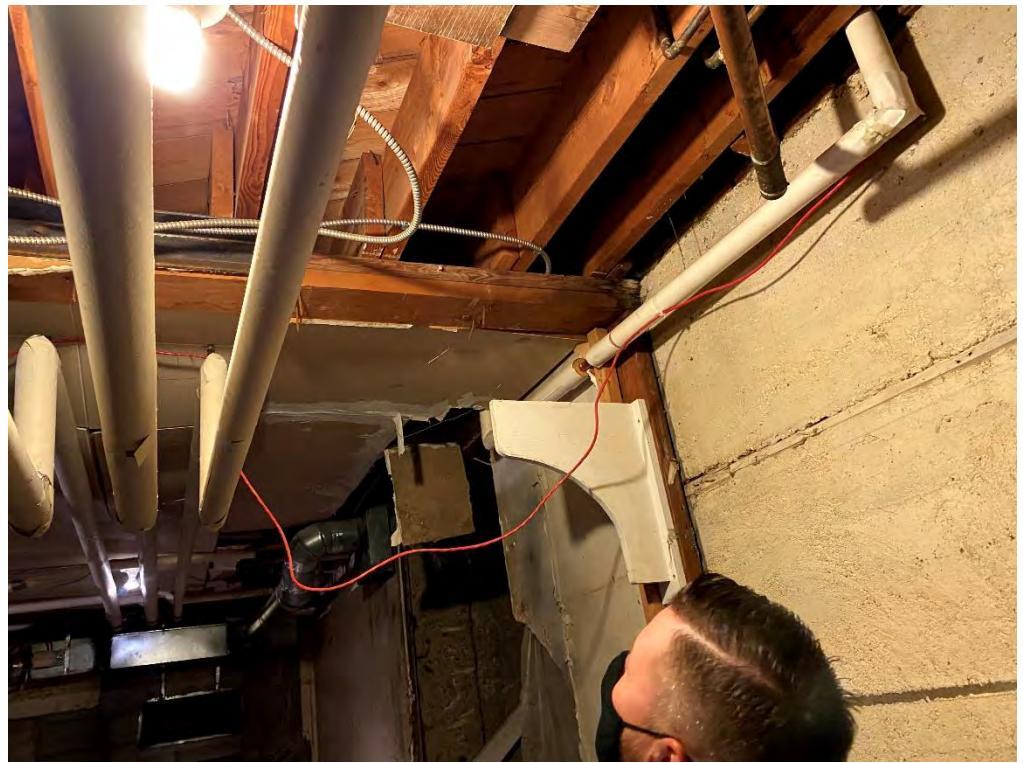
Photo 4- Basement Load Bearing Walls Removed

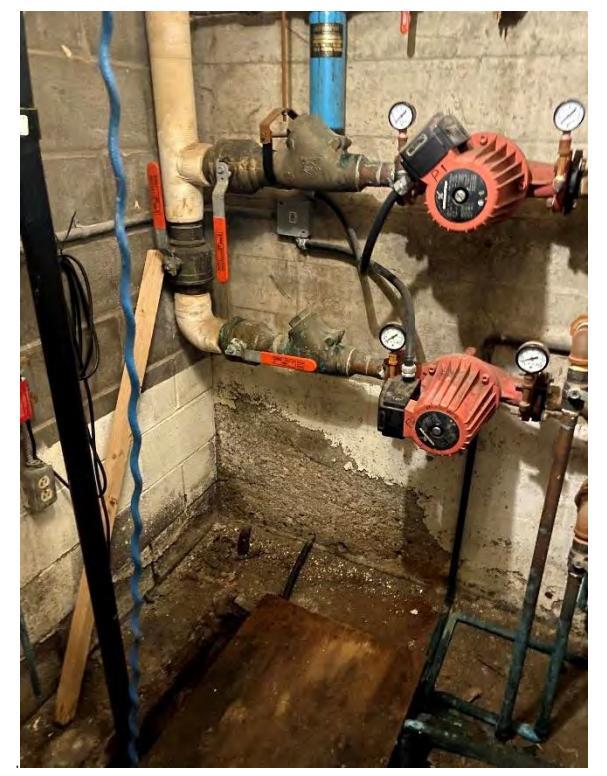
Photo 6- Moisture Infiltration Evident Near Base of Foundation Walls

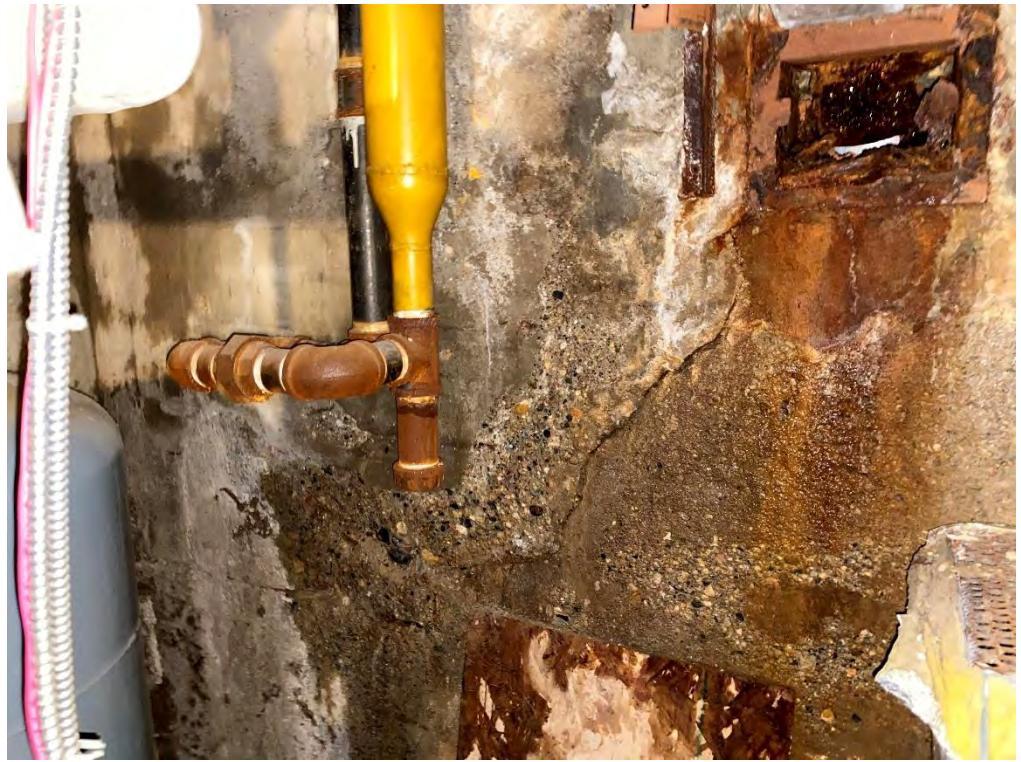
Photo 7- Deteriorating Foundation Wall Condition, Moisture Infiltration

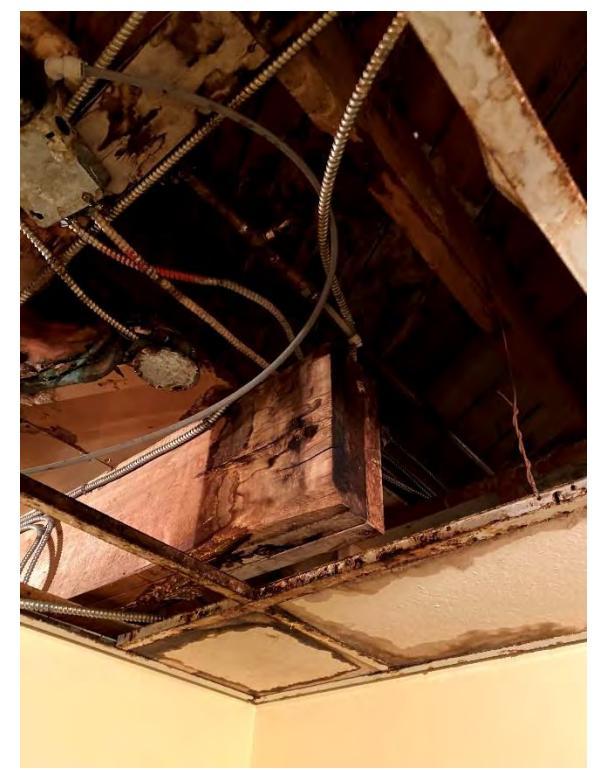
Photo 8- Signs of Moisture Damage Present in Main Floor Structure

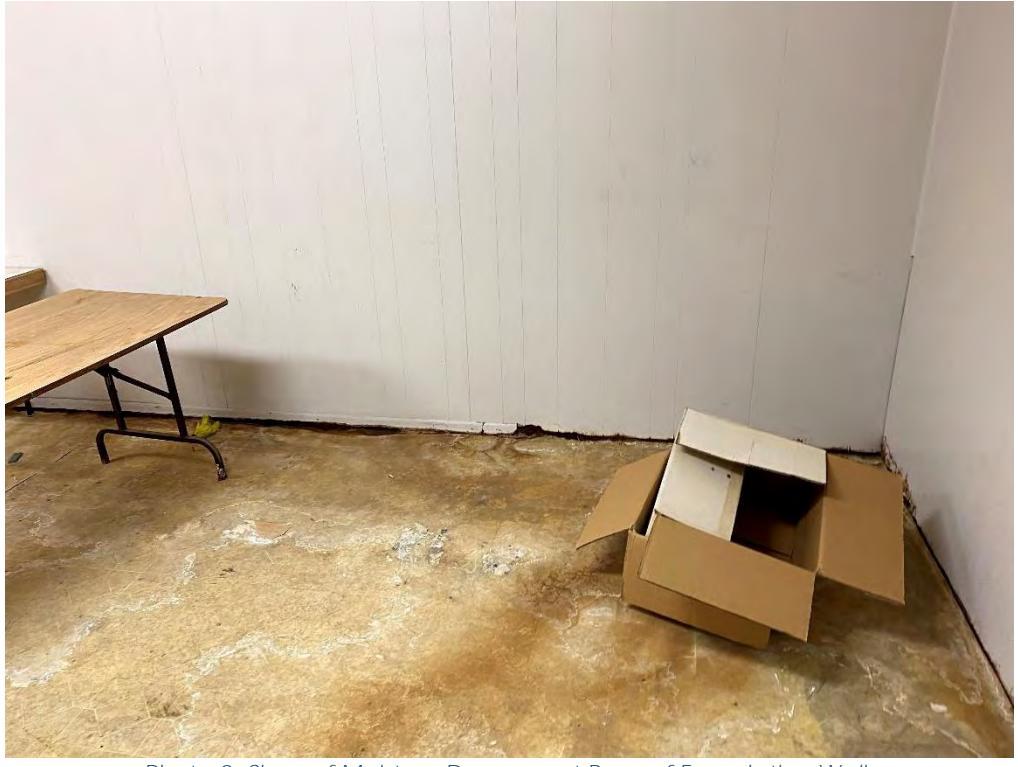
Photo 9- Signs of Moisture Damage at Base of Foundation Walls

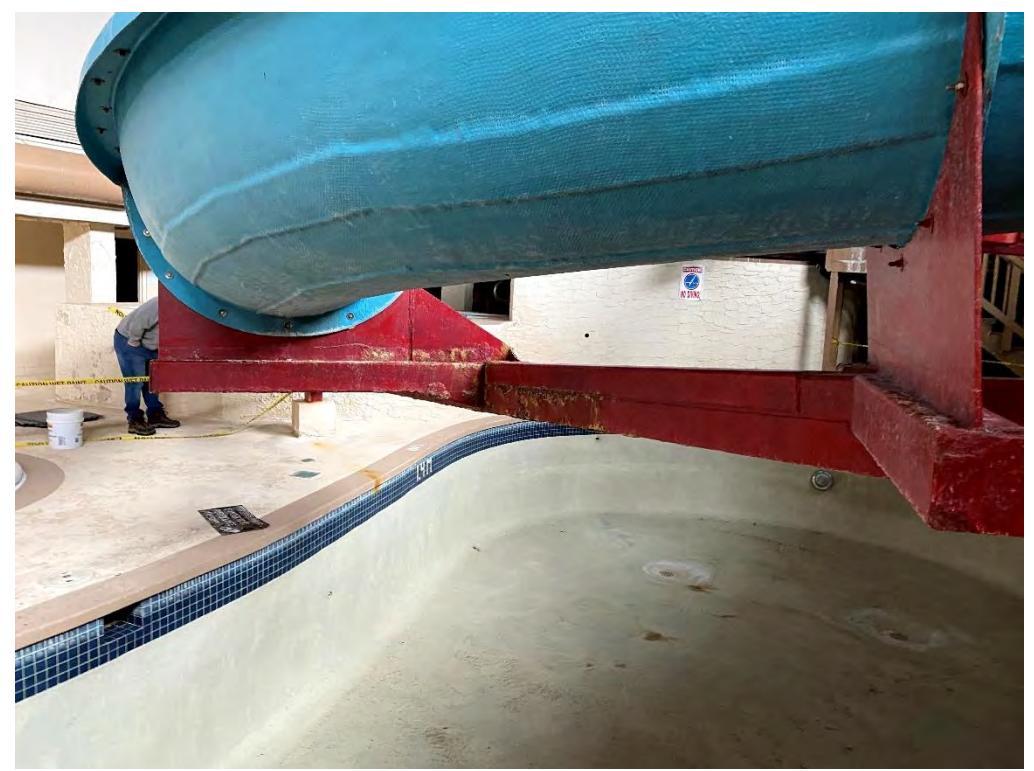
Photo 10- Deteriorated Slide Supports

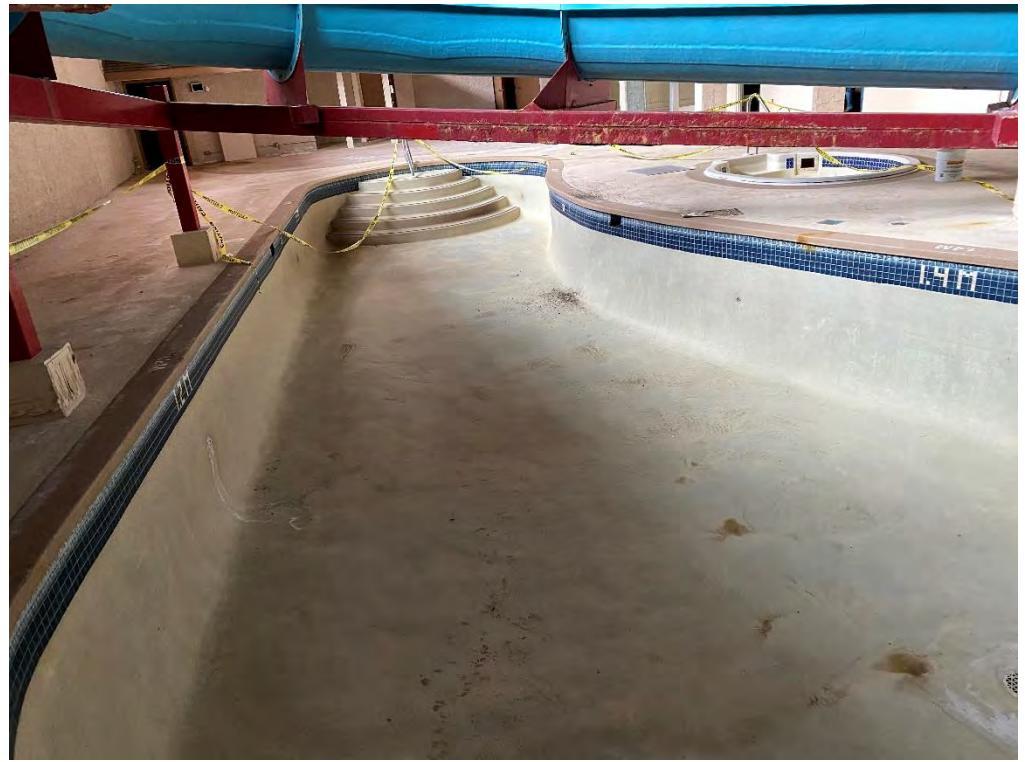
Photo 11- Deteriorated Slide Supports/Pool Basin

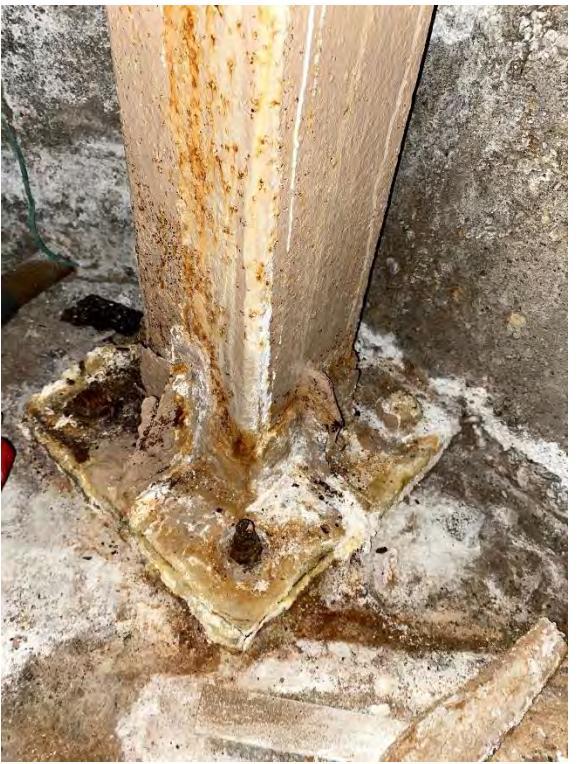
Photo 12- Severely Corroded Waterslide Column

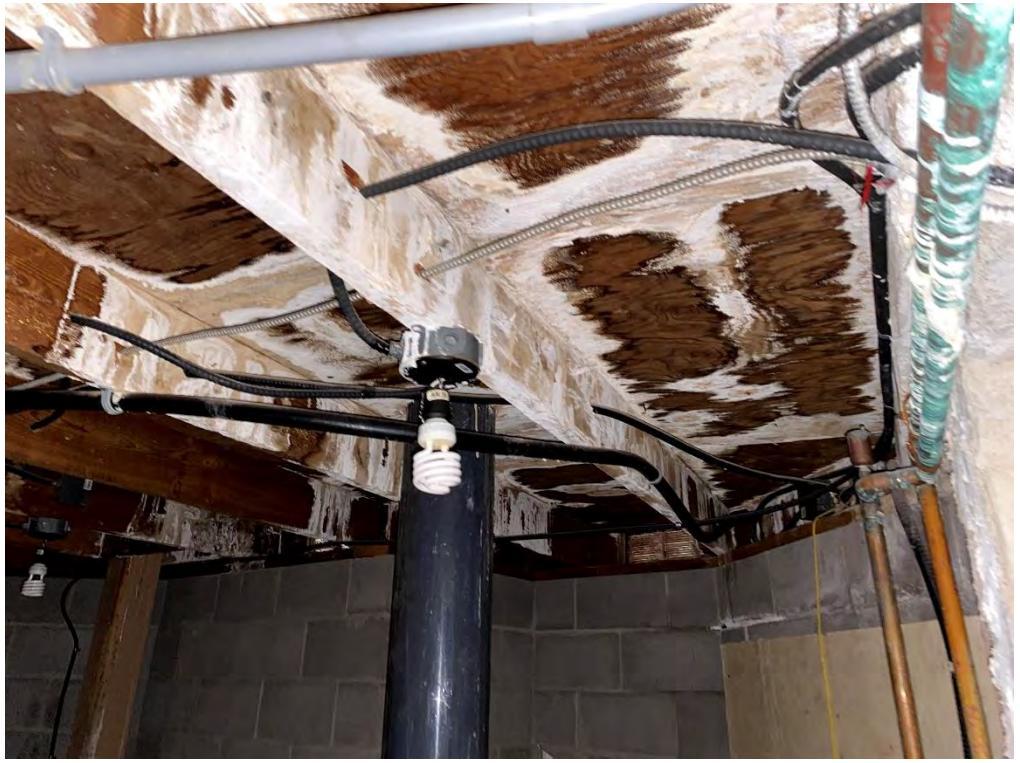
Photo 13- Severely deteriorated pool mechanical roof

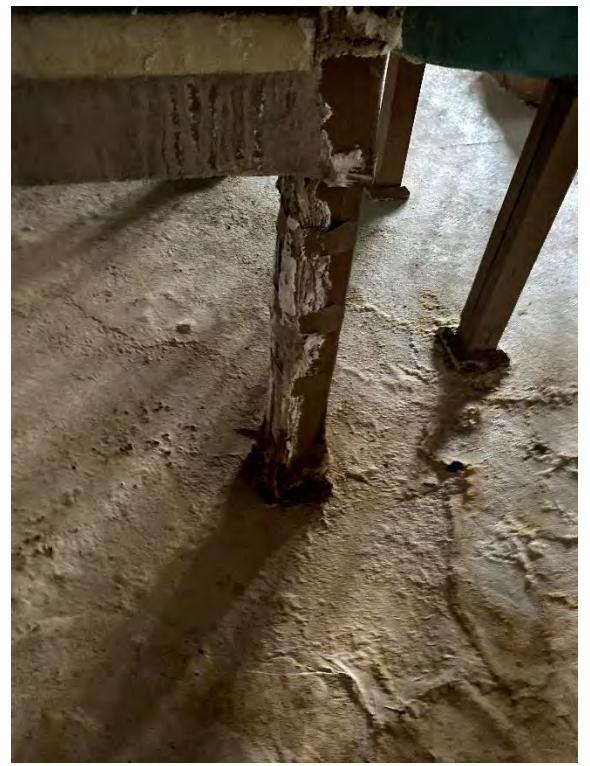
Photo 14- Severely deteriorated Wood platform and landing framing

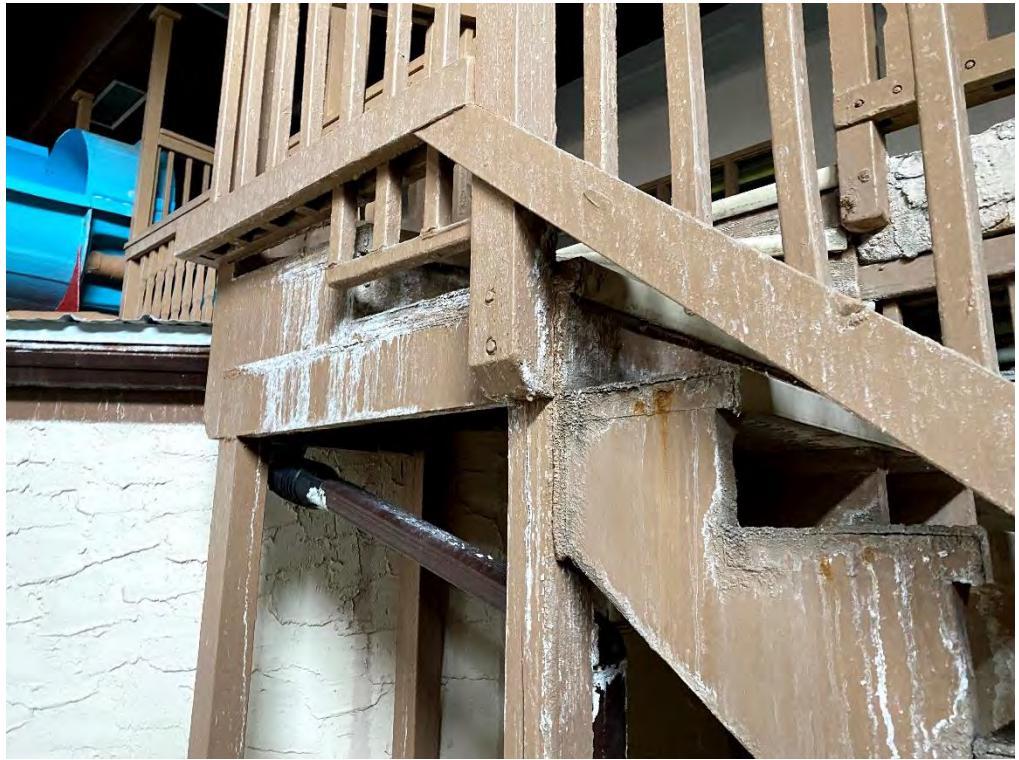
Photo 15- Severely deteriorated pool stair framing

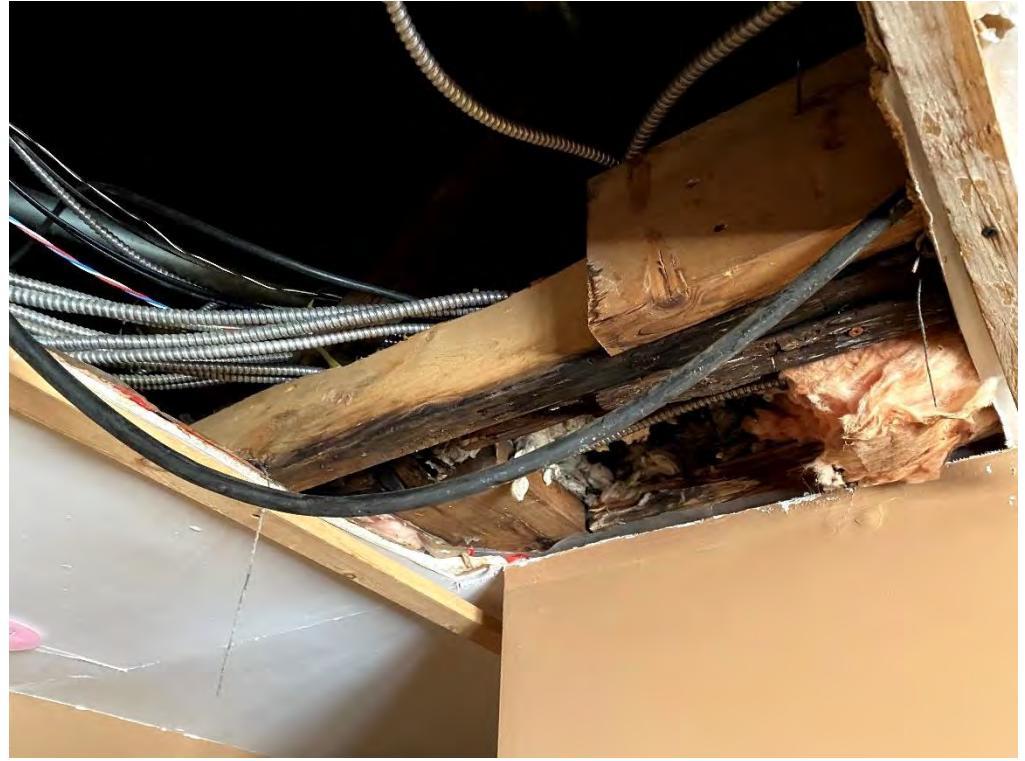
Photo 16- Rotted Roof Structure at South Side Roof

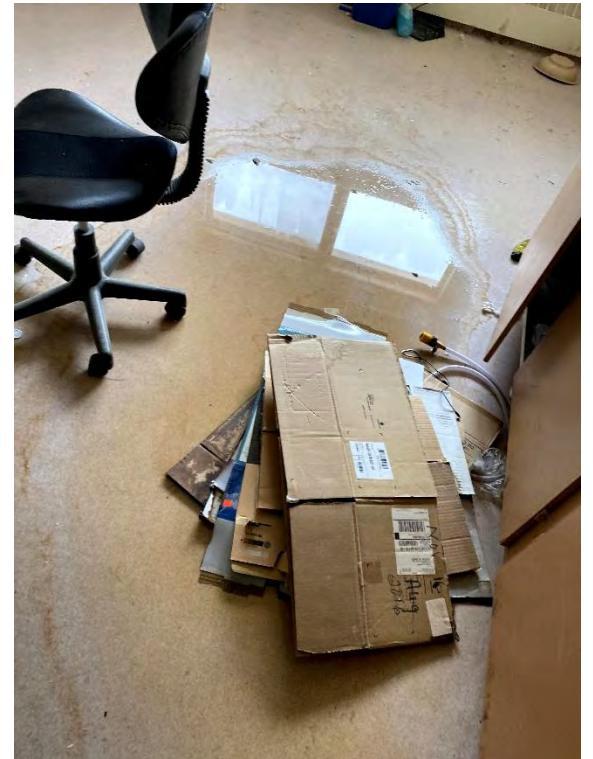
Photo 17- Water Infiltration Evident on Main floor of Building #1

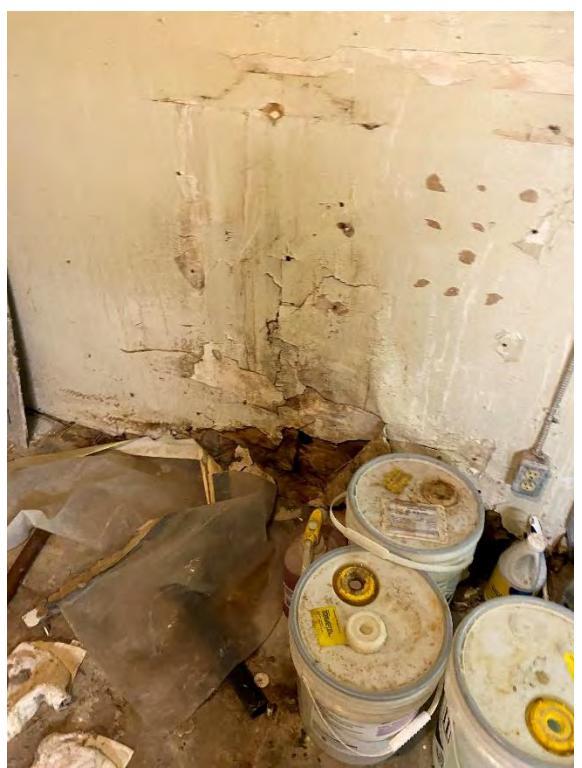
Photo 18- Deteriorated Wall Structure (Building #1)

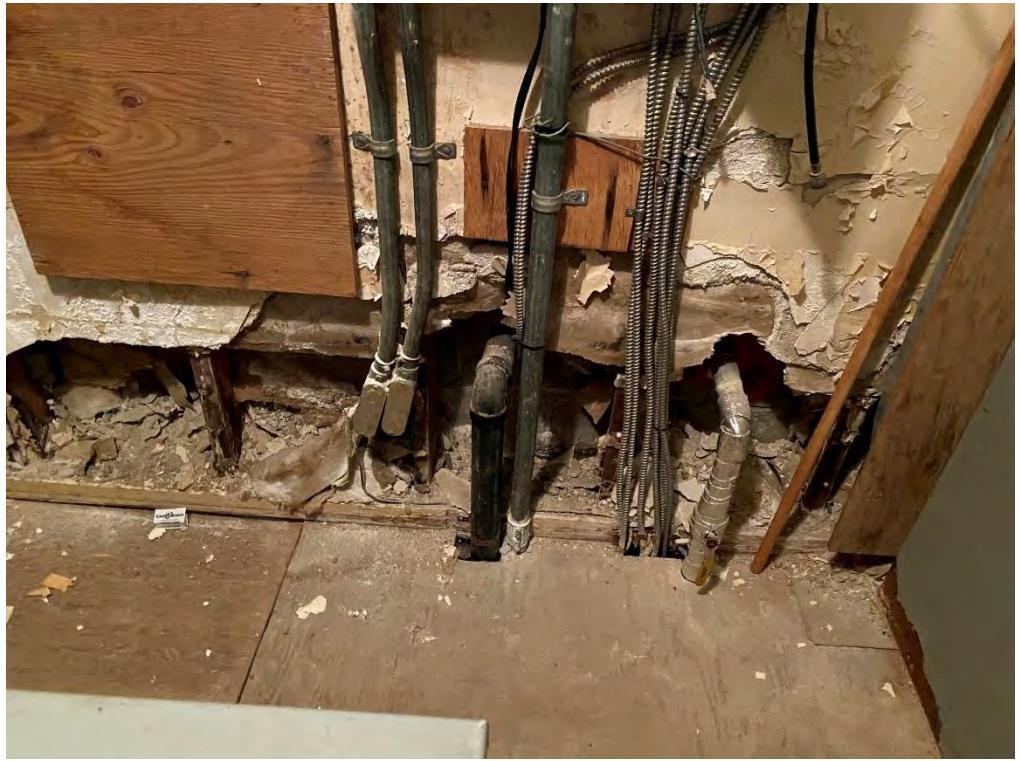
Photo 19- Deteriorated Wall Structure (Building #1)

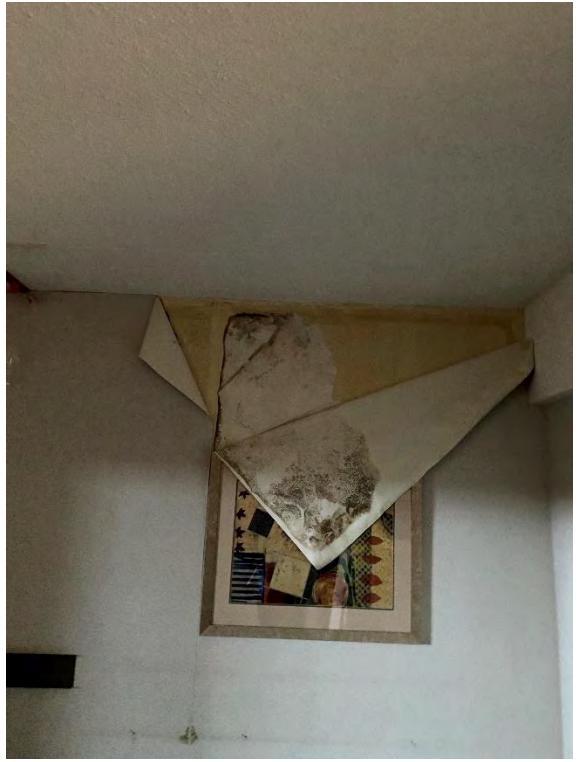
Photo 20- Mold Growth Adjacent to Pool

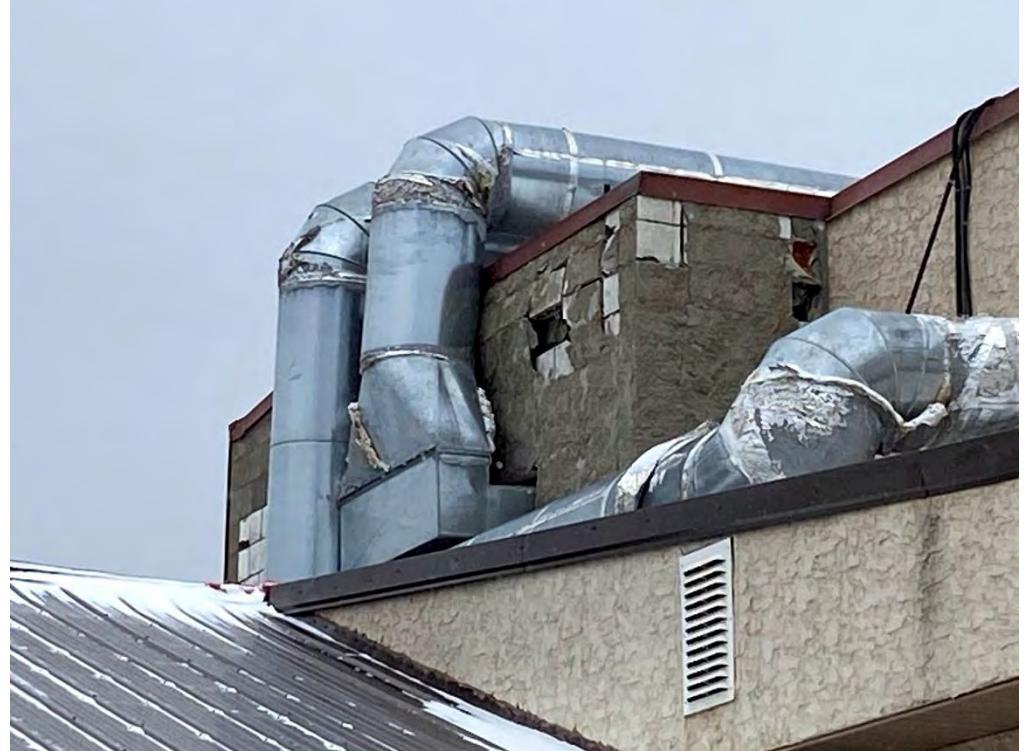
Photo 21- Failing Wall Structure at AHU Penetrations

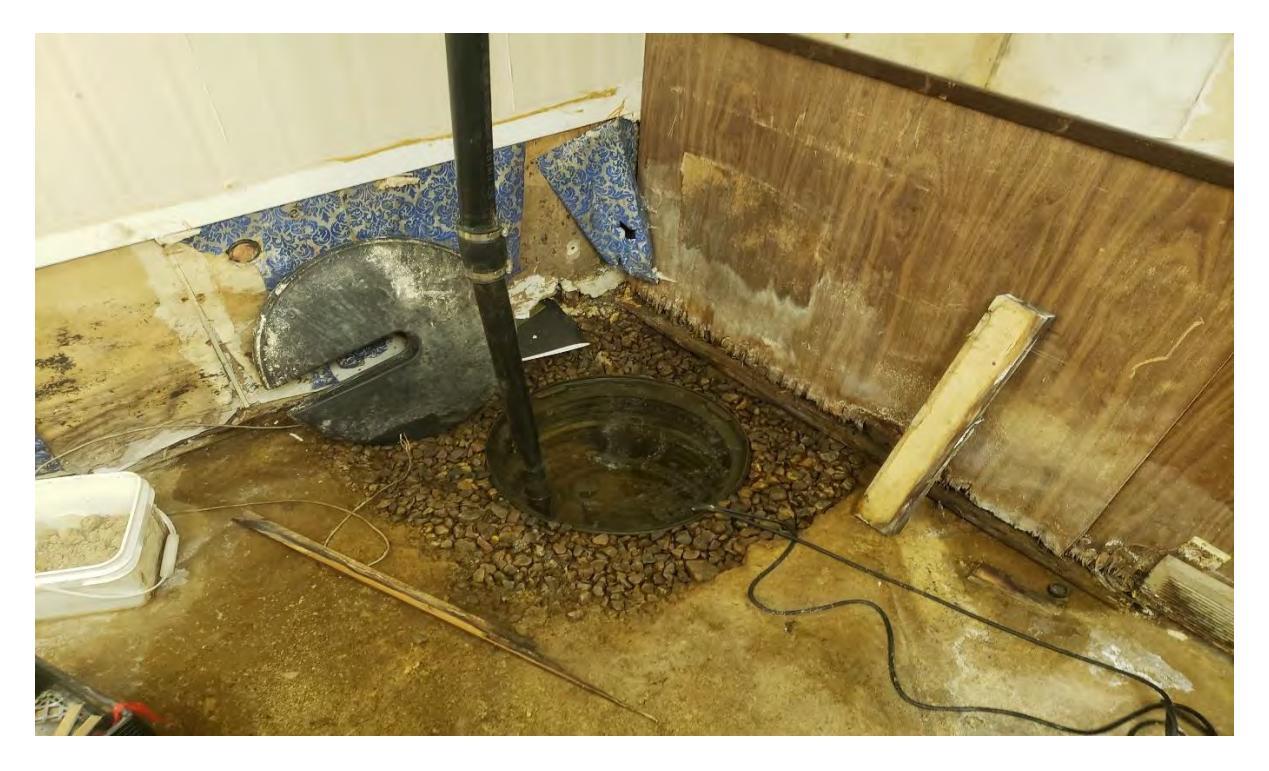
Photo 1 – Lower-level sump full of water. Water damage to walls.

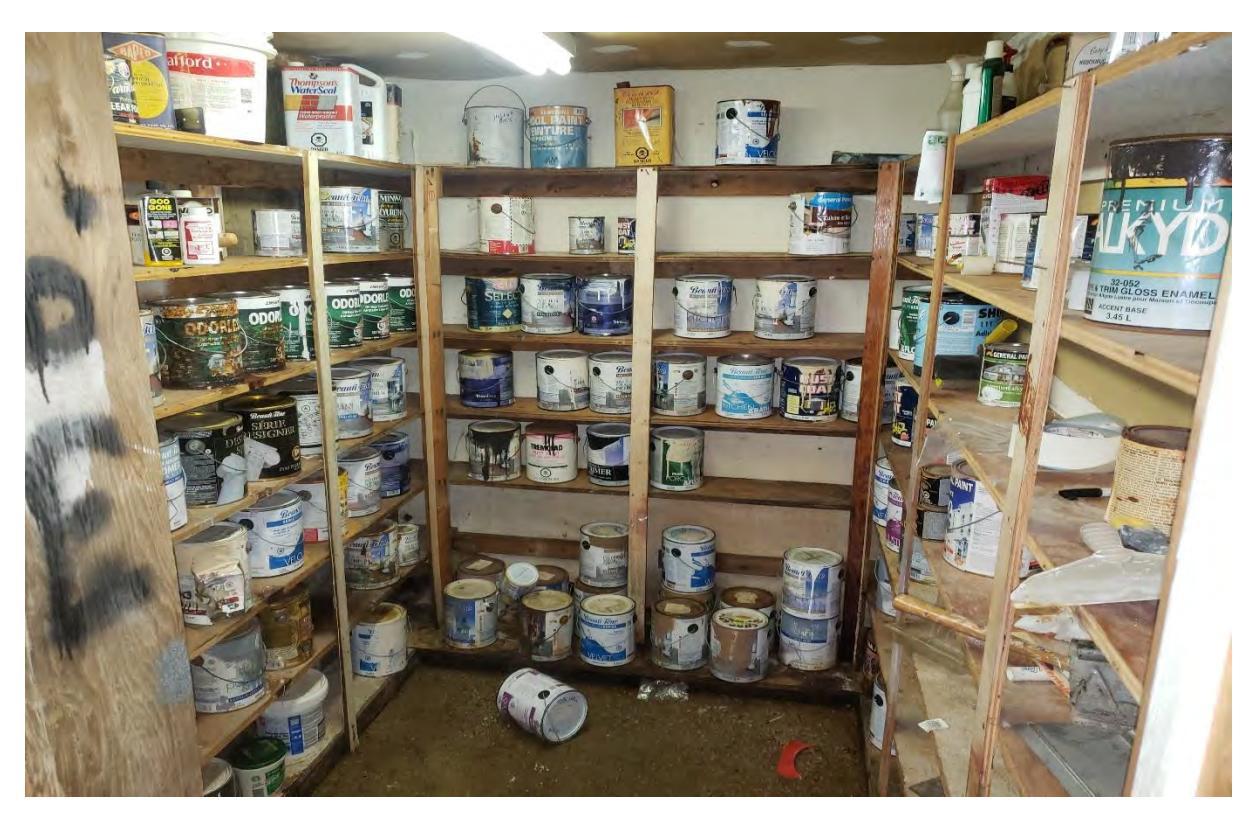
Photo 2 – Housekeeping. Maintenance area paint storage.

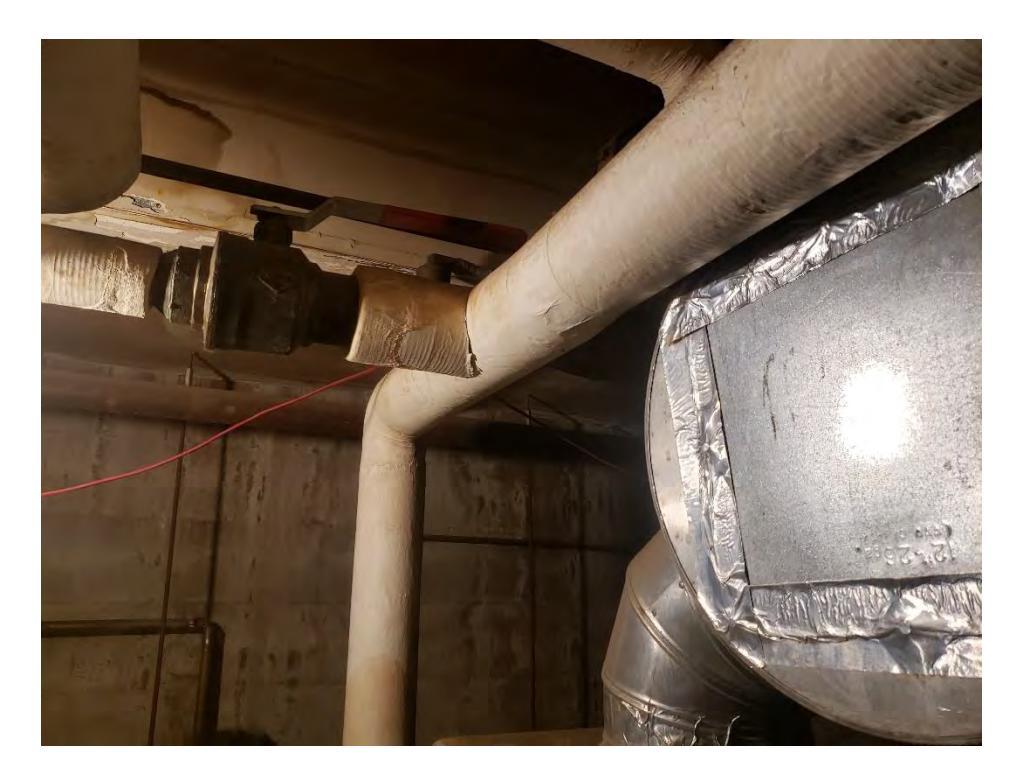
Photo 3 – Boiler room piping insulation elbows. Potential for ACMs. Similar piping insulation found in multiple areas of property.

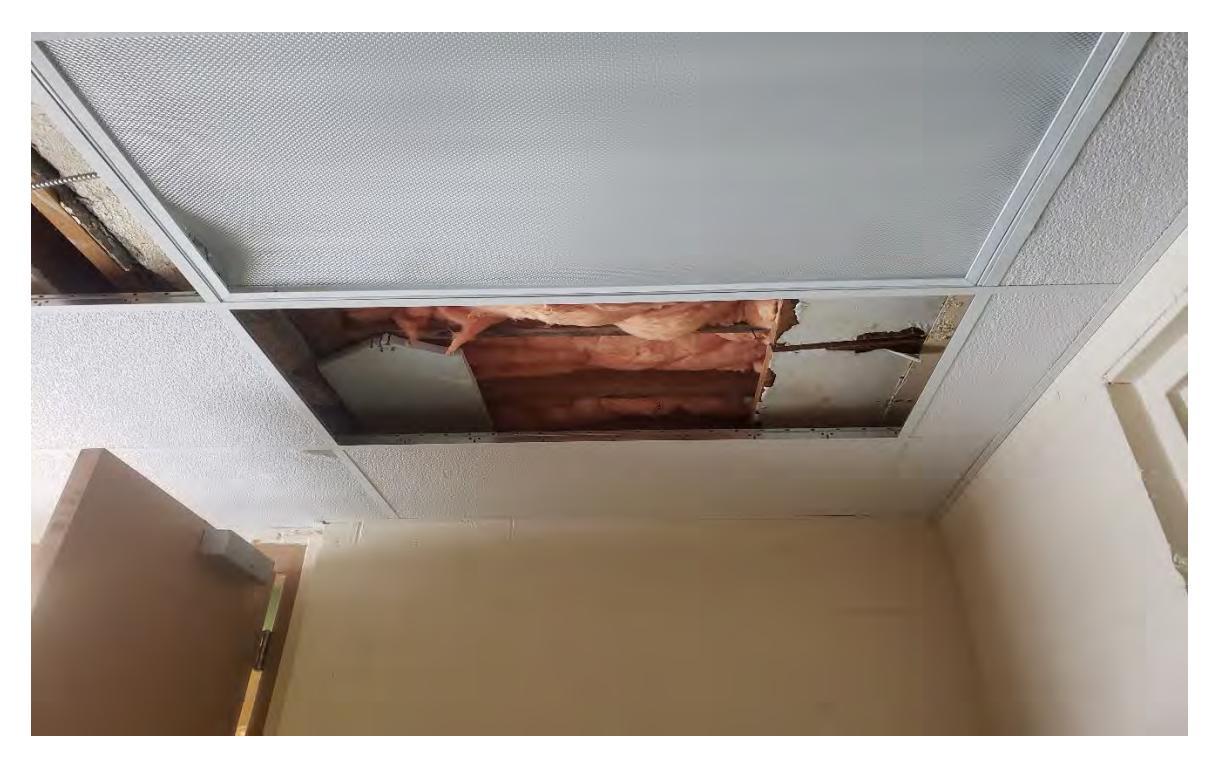
Photo 4 – Ceiling tiles above suspended ceiling. Found throughout property. Potential for ACMs.

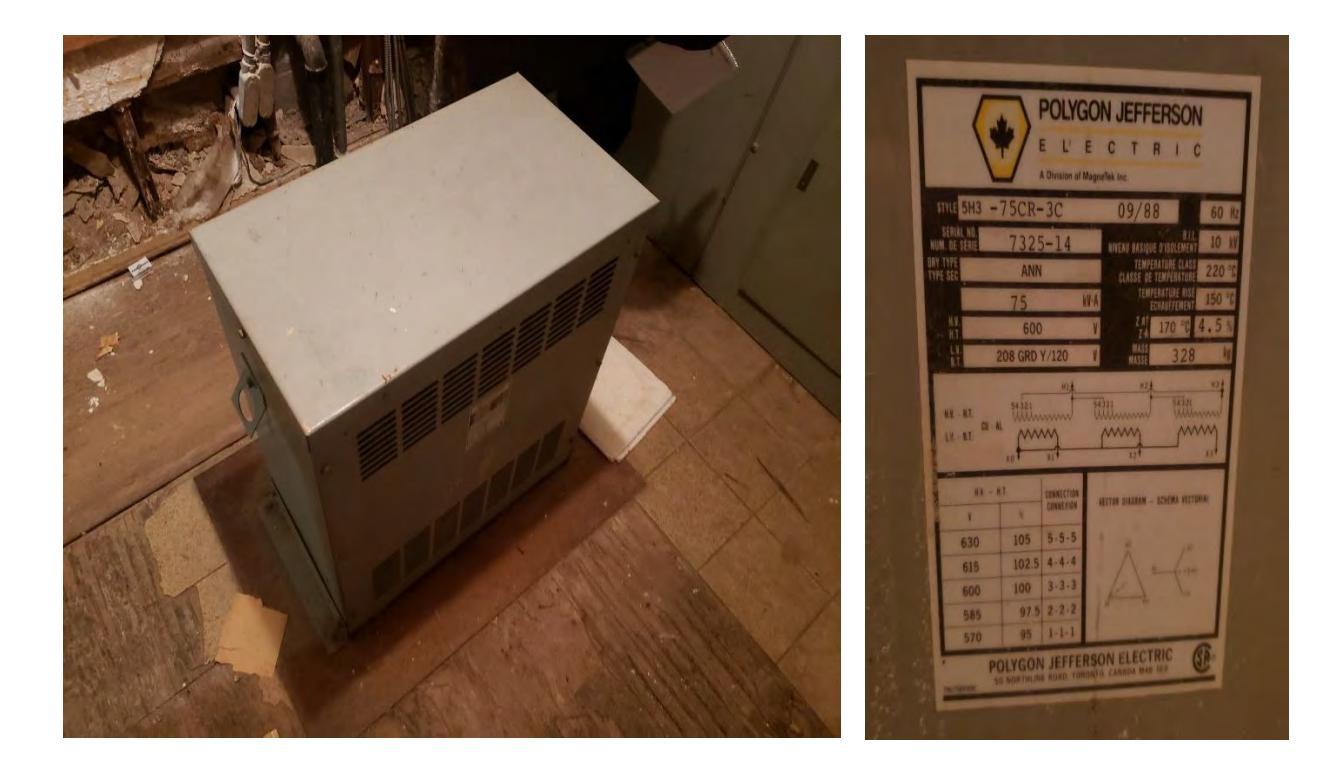
Photo 5 – Electrical room transformer. Potential for PCBs.
