CITY OF YORKTON REGULAR COUNCIL MEETING AGENDA

Building Condition Assessment Report Former Ramada Inn 110 Broadway Ave E. Yorkton, Saskatchewan

RE: YORKTON HOTEL STRUCTURAL CONDITION ASSESSMENT YORKTON, SK FILE NO. 119560

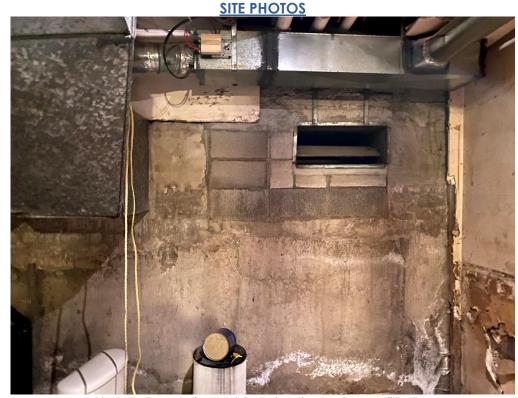
- Exposed sections of the foundation walls were noted to be in poor condition. The interior face of the walls appears to be deteriorating due to moisture infiltration and multiple foundation cracks/damage were noted.

Photo 1- Foundation Wall Deterioration/Moisture Infiltration

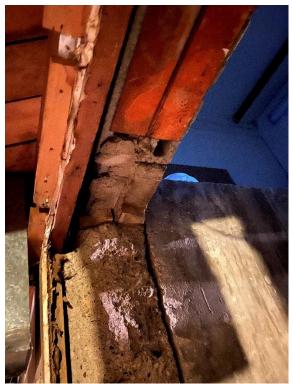
Photo 2- North Wall Lintel Not Properly Bearing on Foundation

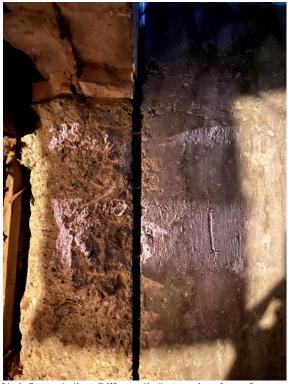
Photo 3- North Stair Foundation Differentially Moving from Basement Foundation

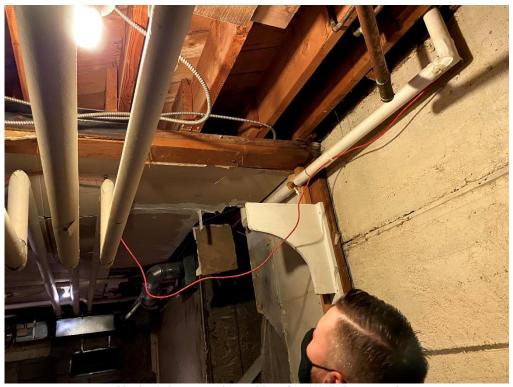
Photo 4- Basement Load Bearing Walls Removed

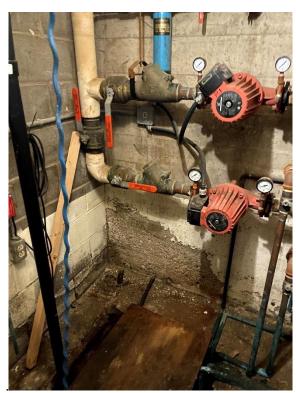
- Most of the perimeter foundation walls in the basement were covered in finishes at the time of this
 review; however, much of the finishes covering the walls were noted to be showing signs of
 moisture damage, particularly near the base of the walls which we believe indicates moisture
 infiltration through the basement walls is likely occurring.

Photo 6- Moisture Infiltration Evident Near Base of Foundation Walls

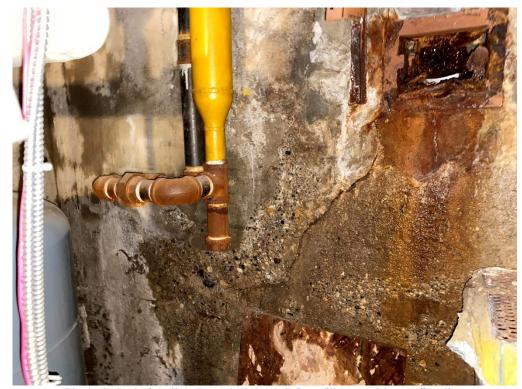
Photo 7- Deteriorating Foundation Wall Condition, Moisture Infiltration

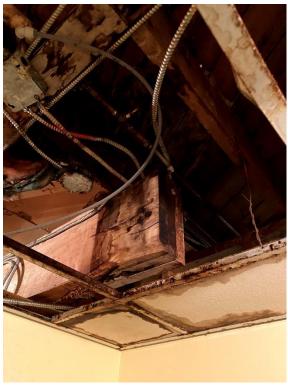
- From within the basement, multiple localized areas of the main floor structure were noted to be
 deteriorated due to moisture damage. These areas will need to be replaced to ensure safe floor
 performance.

Photo 8- Signs of Moisture Damage Present in Main Floor Structure

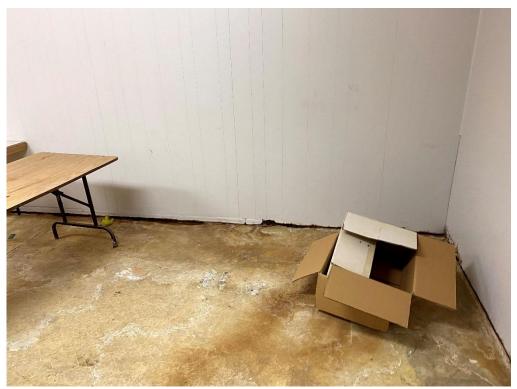
Photo 9- Signs of Moisture Damage at Base of Foundation Walls

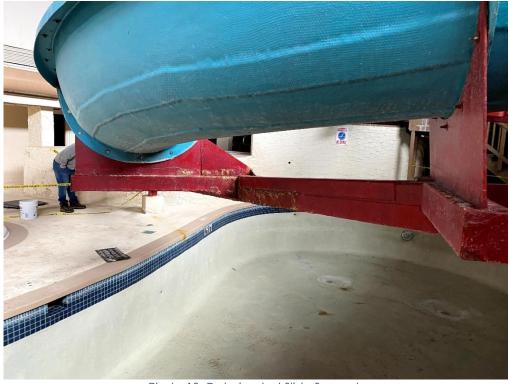
- The waterslide supporting steel structure is in very poor condition and experiencing significant corrosion in most locations. We believe replacement of the waterslide supporting structure is required.

Photo 10- Deteriorated Slide Supports

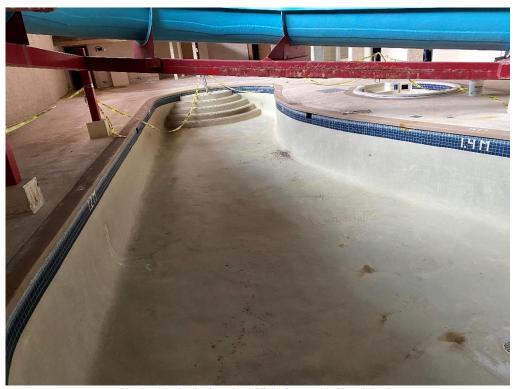
Photo 11- Deteriorated Slide Supports/Pool Basin

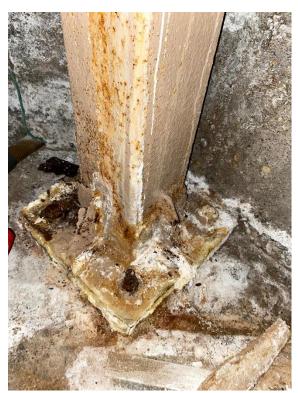
Photo 12- Severely Corroded Waterslide Column

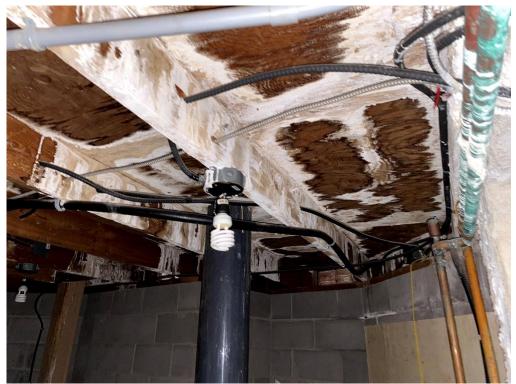
Photo 13- Severely deteriorated pool mechanical roof

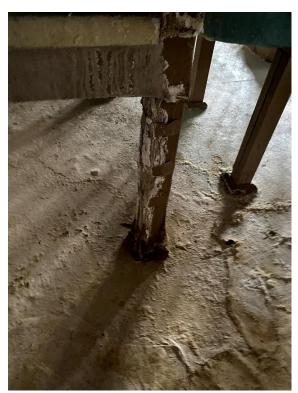
Photo 14- Severely deteriorated Wood platform and landing framing

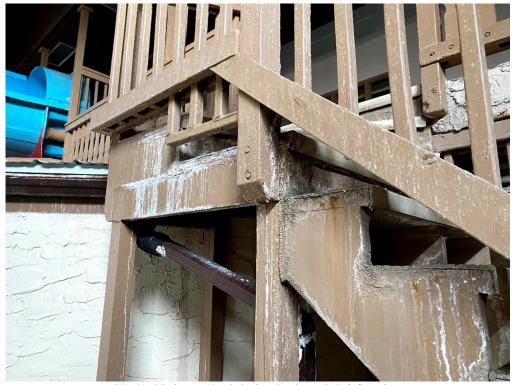
Photo 15- Severely deteriorated pool stair framing

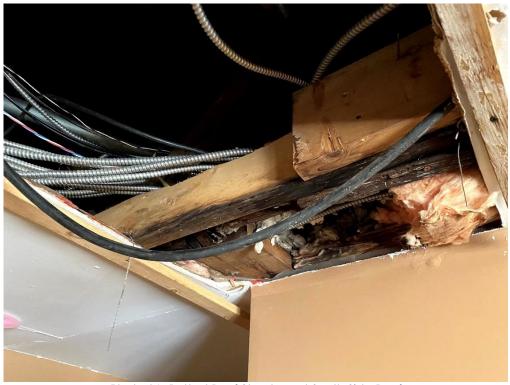
- The roof structure along the south side of this building appears to have been experiencing leaking for some time as multiple areas of the ceiling were noted to be deteriorating and at exposed areas rotting wood sections were noted on the existing trusses. Additionally, puddles of water were noted on the floor throughout multiple areas of the main floor. Buckets collecting water were also noted in multiple locations of opened sections of the ceiling.

Photo 16- Rotted Roof Structure at South Side Roof

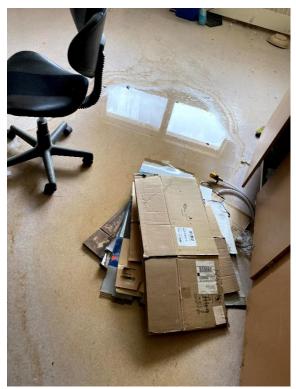
Photo 17- Water Infiltration Evident on Main floor of Building #1

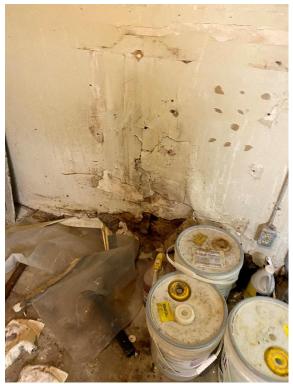
- Multiple areas of the south wall structure were noted to be showing signs of deterioration which we believe is related to moisture infiltration through the building envelope.

Photo 18- Deteriorated Wall Structure (Building #1)

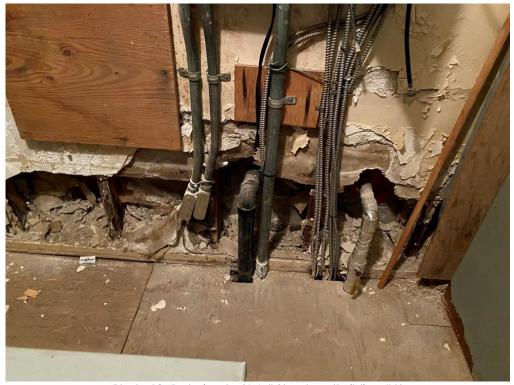
Photo 19- Deteriorated Wall Structure (Building #1)

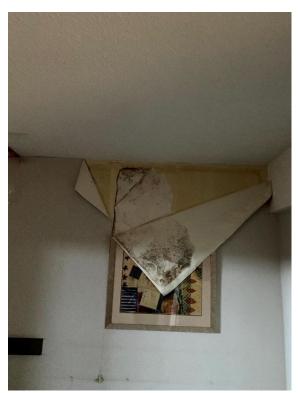
Photo 20- Mold Growth Adjacent to Pool

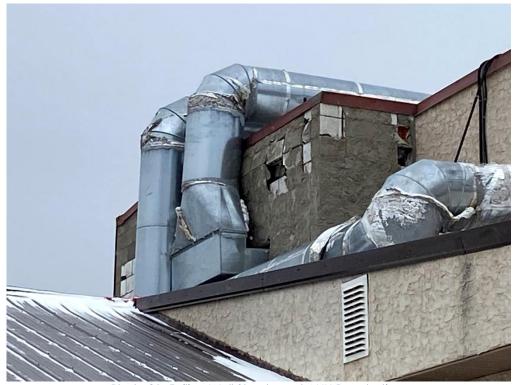
Photo 21- Failing Wall Structure at AHU Penetrations

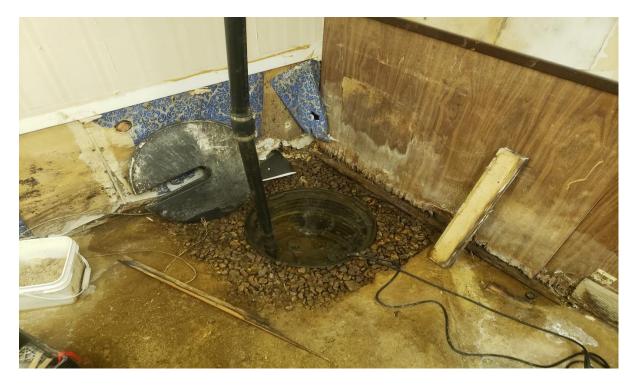
Photo 1 – Lower-level sump full of water. Water damage to walls.

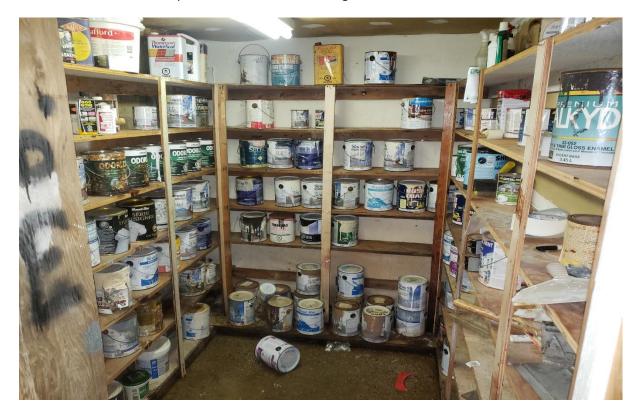
Photo 2 – Housekeeping. Maintenance area paint storage.

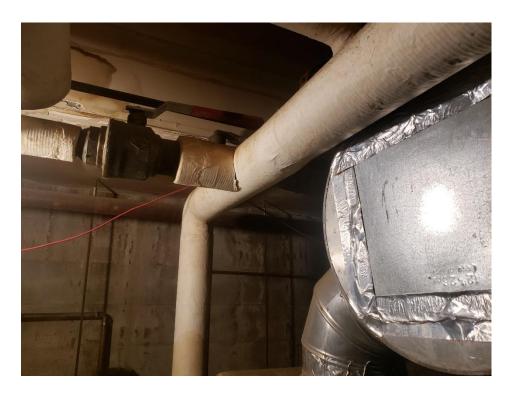
Photo 3 — Boiler room piping insulation elbows. Potential for ACMs. Similar piping insulation found in multiple areas of property.

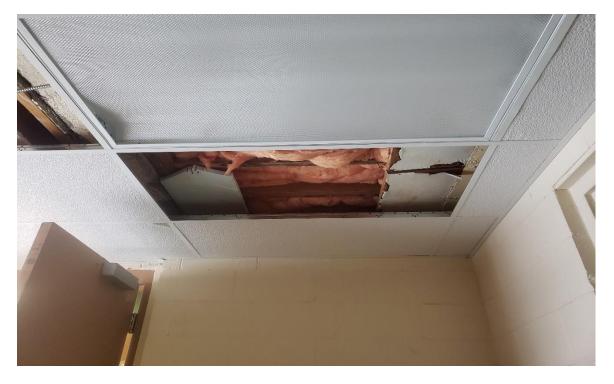
Photo 4 – Ceiling tiles above suspended ceiling. Found throughout property. Potential for ACMs.

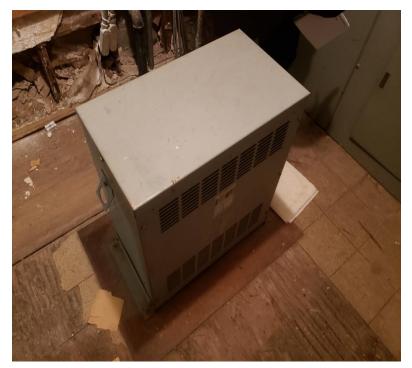
Photo 5 – Electrical room transformer. Potential for PCBs.
