CITY OF YORKTON <u>REGULAR COUNCIL MEETING AGENDA</u> Monday, June 28, 2021 - 5:00 p.m.

Building Condition Assessment Report

Former Ramada Inn

RE: YORKTON HOTEL STRUCTURAL CONDITION ASSESSMENT YORKTON, SK FILE NO. 119560

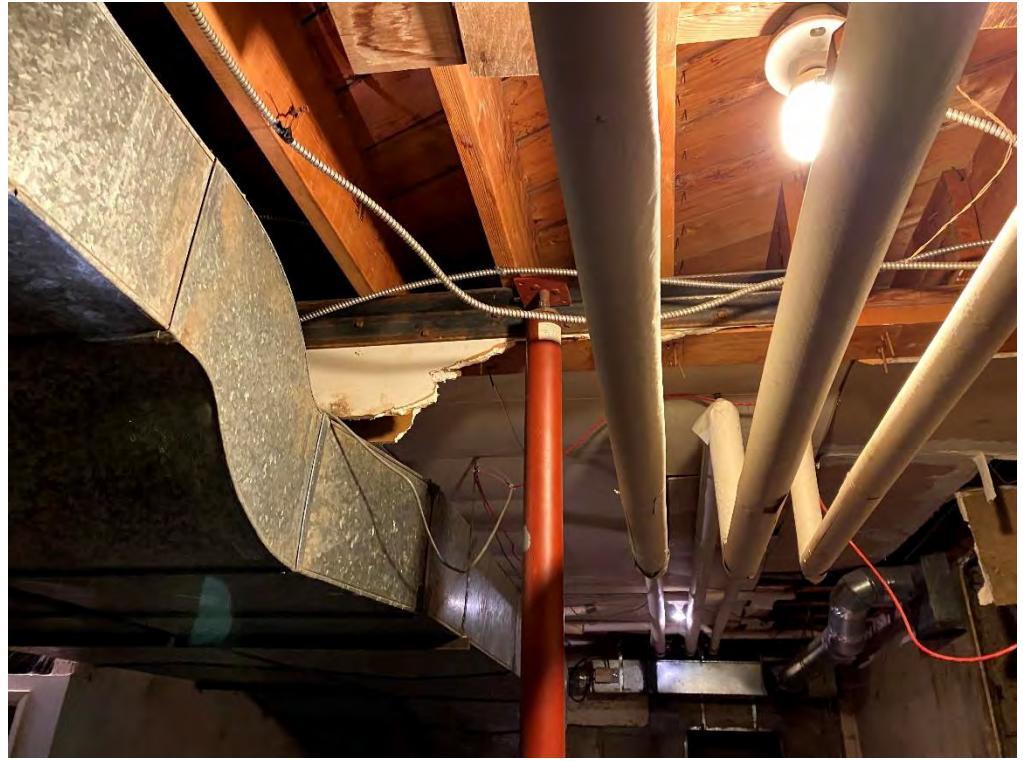
Photo 5- Support Post Below Old Bearing Wall Location

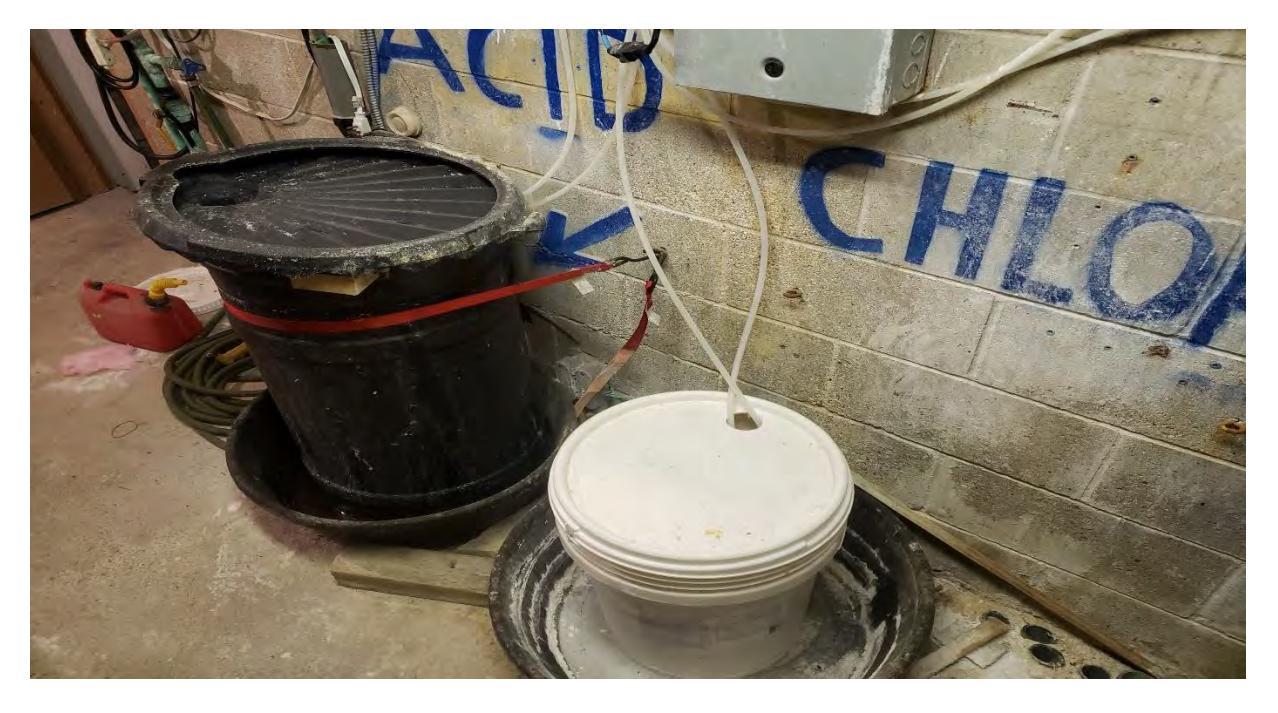
Photo 6 – Pool chemical room.

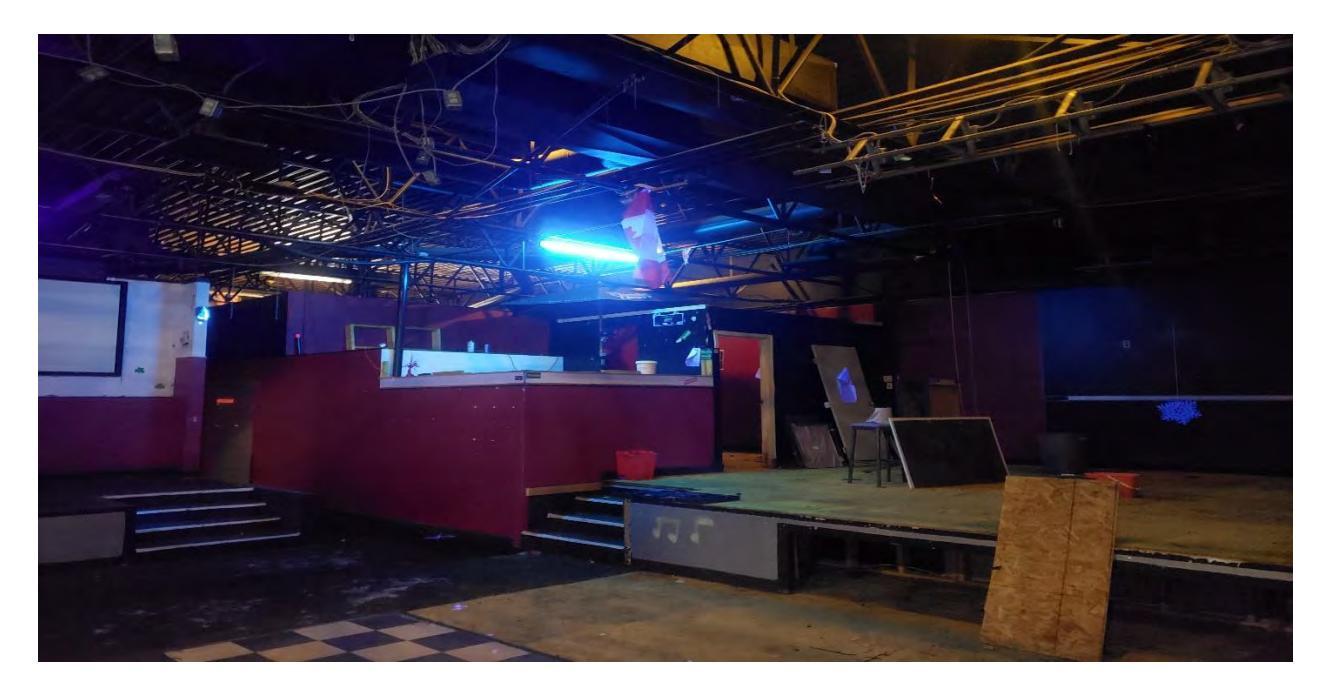
Areas of water damage and microbial growth were noted in the basement areas, in the nightclub (Holly's), and the laundry areas of the building. This includes areas of black mould growth in the administrative offices.

Photo 7 – Holly's bar and nightclub.

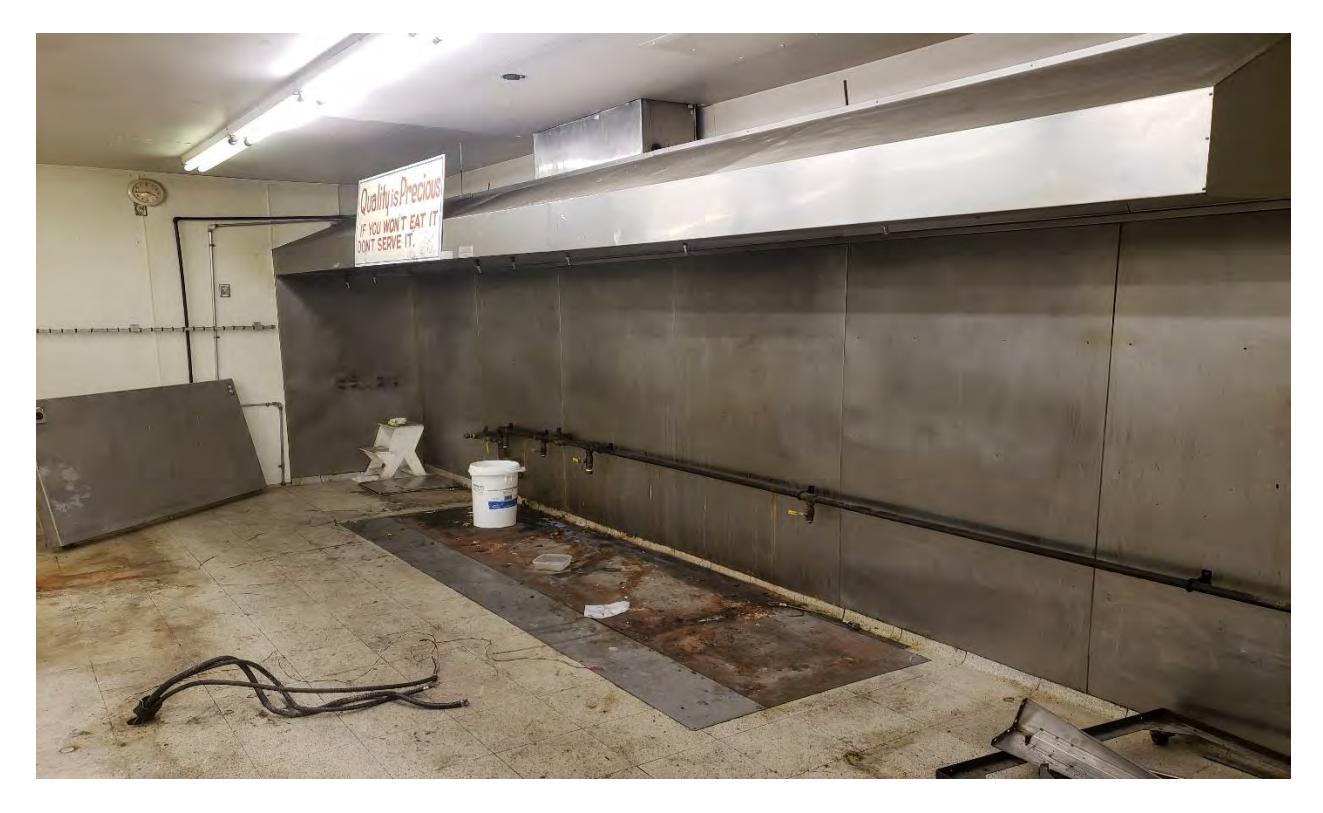
Photo 8 – Hotel restaurant kitchen.

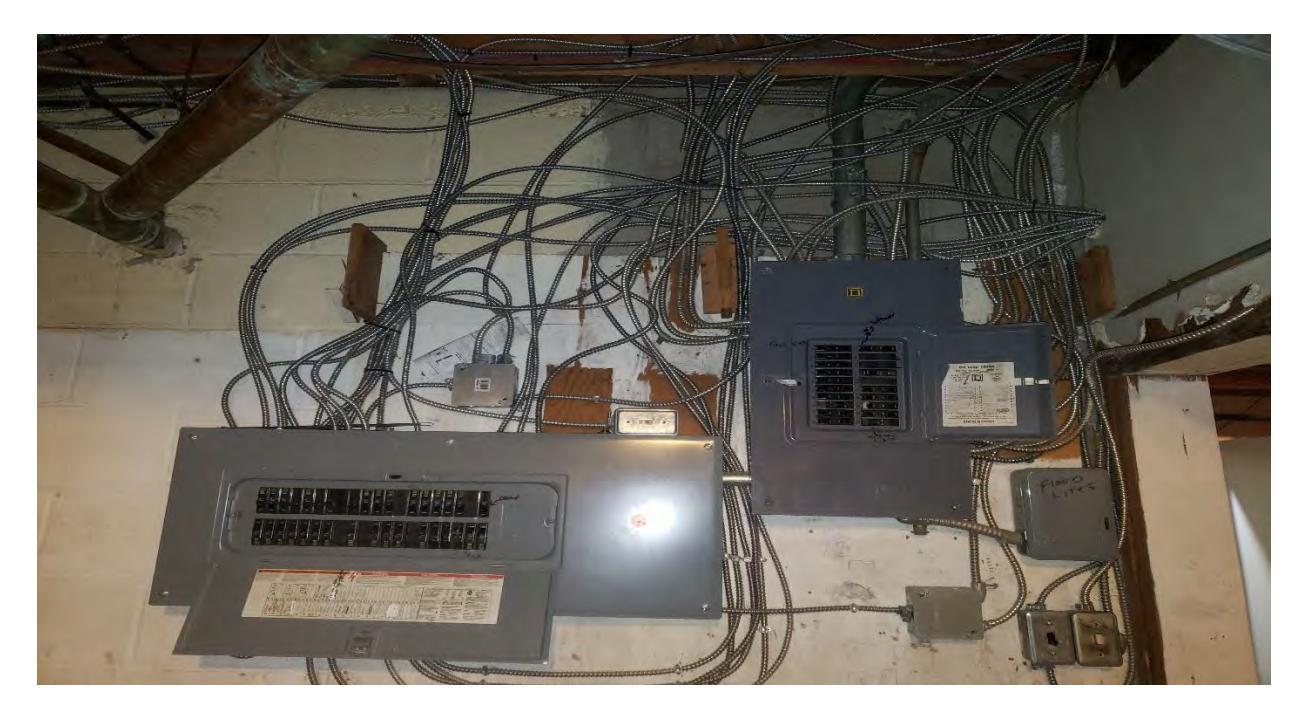
Photo 9 – Lower-level electrical panels.

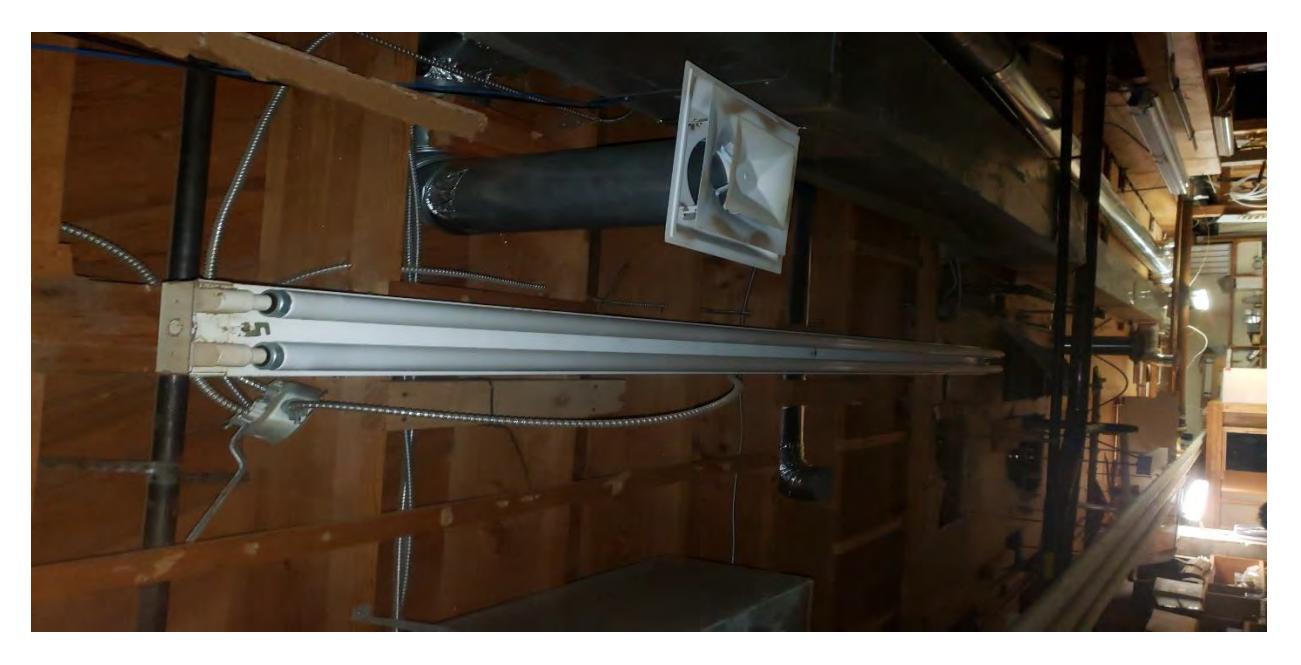
LEAD	Potential sources observed during the site visit included original piping in the basement mechanical and concrete paint on the basement level.	Sample and inventory before demolition plan development.
OZONE DEPLETING SUBSTANCES (ODSS)	Sources are limited to A/C units, rooms and rooftop, and refrigeration units.	Inventory and evaluation before demolition or removal.
ELECTROMAGNETIC FIELDS (EMFS)	No potential sources were identified.	None
NOISE AND VIBRATIONS	Limited to road and railway traffic.	None
MICROBIAL GROWTH	Potential sources from water damage to floors and ceiling as well as standing water in some areas.	Sample and inventory before demolition plan development.
MERCURY	Potential sources identified were limited to lighting and thermostats.	None

Photo 10 – Lower-level fluorescent lighting ballasts.
